RE: Variance Request Response, Eaton Sugar Beet Factory

Please find herein Environmental Restoration LLC's (ERLLC) response to your request for additional information regarding work area 10 at the Eaton Sugar Beet Factory (ESBF). We are referring to work area 10 as the Kiln/Dry building for the purposes of this request.

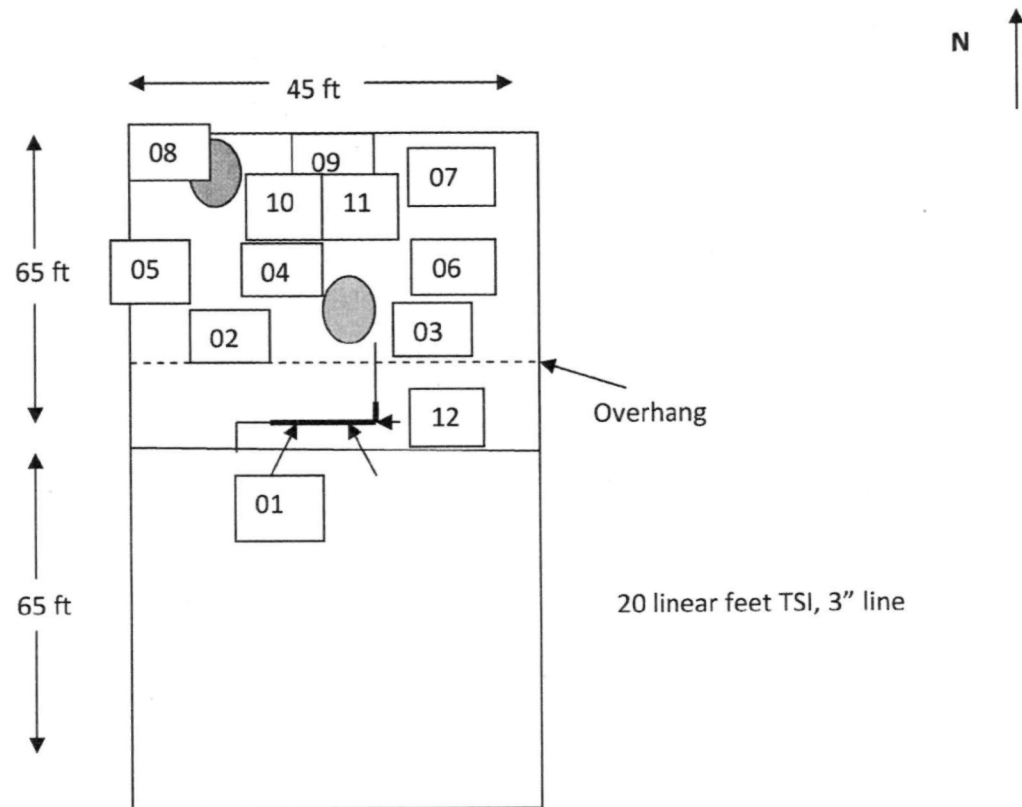
**EATON SUGAR BEET FACTORY KILN/DRY BUILDING  
SOIL/DEBRIS SAMPLE LOCATIONS, OCT. 12, 2011**

Koch Environmental Health collected samples of soil/debris in 12 different locations on the ground of the structure for analysis by Polarized Light Microscopy on October 12, 2011. Samples were collected in large (1 gallon) sealable storage bags such that each sample represented approximately ½ gallon of material. Samples were collected in areas directly beneath existing TSI, beneath the "crow's nest", and from other areas of the floor deemed by the Asbestos Inspector to be "worst case" with respect to the amount of debris in those locations. See the attached sketch for exact sample locations. No asbestos was detected in any of the 12 soil/debris samples. Sample descriptions, locations and results are described below:

Sample #	Date	Sample Description & Location	Type S,T,M	Condition G,D,SD,PSD	Estimated QTY	Results (%asbestos)
1012-01	10/12/11	Soil / Debris, Kiln/Dry Bldg. - S. end beneath TSI pipe	M	-	-	ND
1012-02	10/12/11	Soil / Debris, Kiln/Dry Bldg. - N. side center, outside of overhang	M	-	-	ND
1012-03	10/12/11	Soil / Debris, Kiln/Dry Bldg. - E. side outside of overhang	M	-	-	ND
1012-04	10/12/11	Soil / Debris, Kiln/Dry Bldg. - center of building, N. of S. kiln stack	M	-	-	ND
1012-05	10/12/11	Soil / Debris, Kiln/Dry Bldg. - inside W. entry on floor	M	-	-	ND
1012-06	10/12/11	Soil / Debris, Kiln/Dry Bldg. - E. center of building	M	-	-	ND
1012-07	10/12/11	Soil / Debris, Kiln/Dry Bldg. - E. side N. end beneath crows nest	M	-	-	ND
1012-08	10/12/11	Soil / Debris, Kiln/Dry Bldg. - N. side of N. kiln stack	M	-	-	ND
1012-09	10/12/11	Soil / Debris, Kiln/Dry Bldg. - N. end center	M	-	-	ND
1012-10	10/12/11	Soil / Debris, Kiln/Dry Bldg. - W. center beneath crows nest	M	-	-	ND

1012-11	10/12/11	Soil / Debris, Kiln/Dry Bldg. - E. center beneath crows nest	M	-	-	ND
1012-12	10/12/11	Soil / Debris, Kiln/Dry Bldg. - E. side under overhang beneath bare TSI pipe	M	-	-	ND

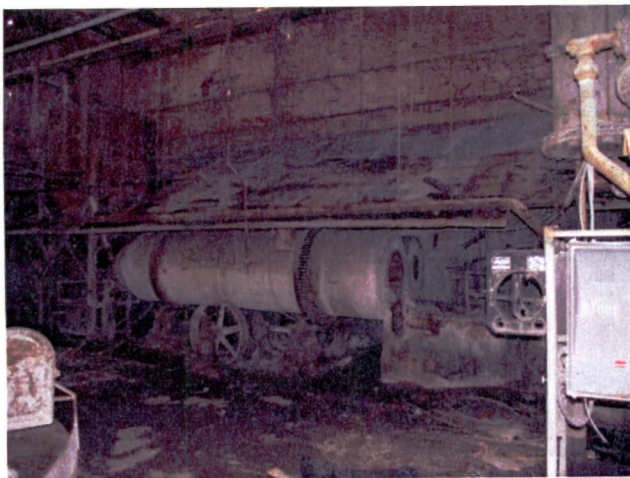
- There is approximately 20 linear feet of TSI underneath an overhang on the south side of the structure. The TSI is on a 3" pipe and is located approximately 10 feet above the ground. The TSI is damaged although there is no visible suspect TSI debris beneath it or underneath the overhang.
- TSI was observed on a large pipe on the south lime roaster. KEH could not determine the amount of material on the south lime roaster from the ground level as it is located near the top of the structure. No visible suspect TSI debris was observed on the ground beneath the pipe.
- Asbestos-containing sealant is present on several penetrations on the lime roasters. The material is cementitious and appears to be in good condition.

"Overhang" (TSI beneath overhang)

ERLLC will erect a mini-containment around the ground-level TSI beneath the overhang and then remove the pipe and TSI via component removal methods. Aggressive final clearance sampling via PCM will be conducted by a CDHPE-certified AMS within the mini-containment upon completion of component removal and final cleaning.

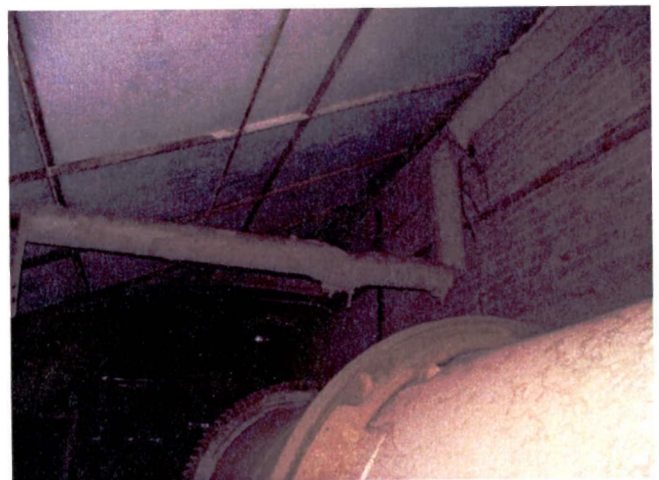
20 l.f. TSI under overhang

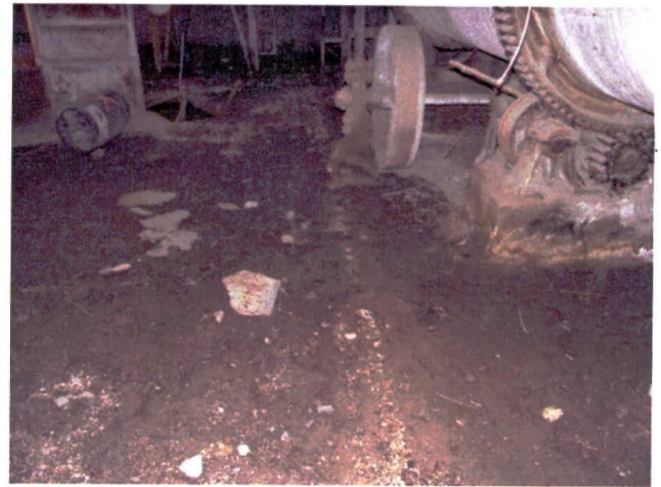
Center of floor depicting debris (no suspect ACM)

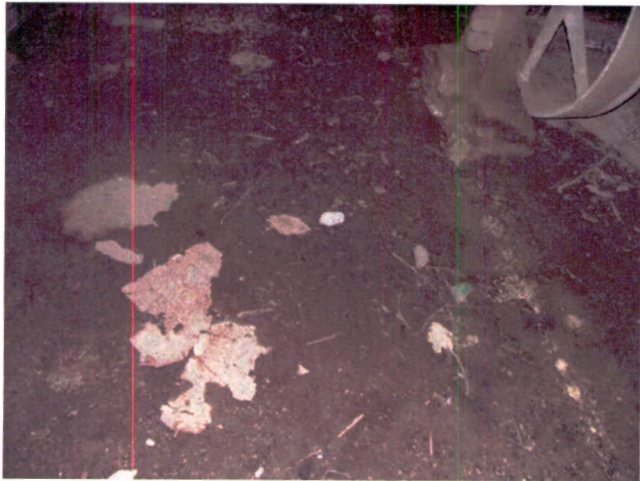
Closeup of debris on floor

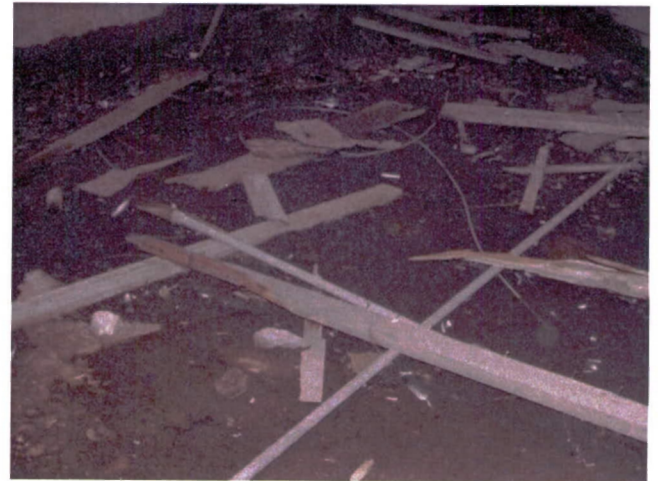
South side of floor debris

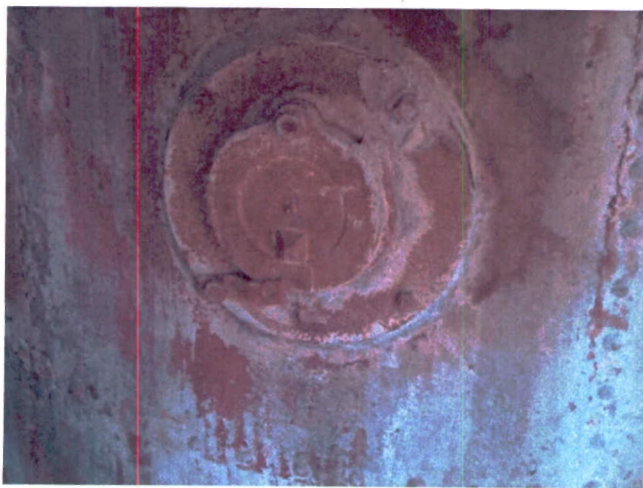
Asbestos-containing sealant on south lime roaster  
(photo provided by EPA START contractor URS)

ERLLC will erect mini-containments at each cementitious sealant penetration location and perform removal via glovebag methods. Alternatively, if the sealant penetrates the component and is unavailable for removal by glove bag, ERLLC may elect to seal the outside of the material with encapsulate and torch cut around the penetration and completely remove the ACM portion of the component. Aggressive final clearance sampling via PCM will be conducted by a CDHPE-certified AMS within the mini-containment upon completion of removal and final cleaning.

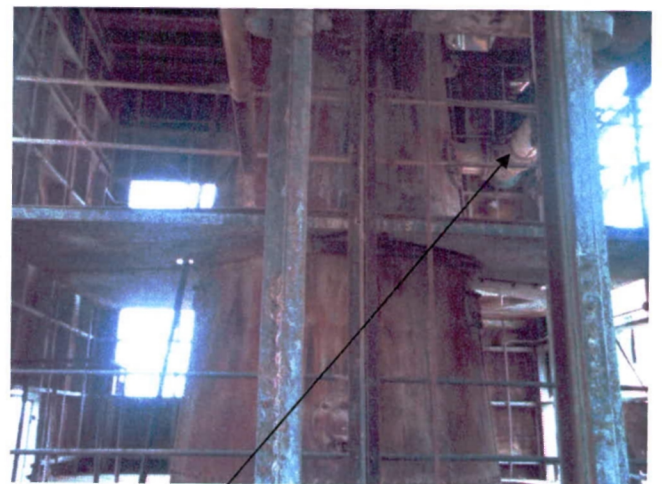
TSI on pipe, south lime roaster  
(photo provided by EPA START contractor URS)

ERLLC will erect a mini-containment around the large pipe on the south lime roaster and remove the TSI via glovebag methods. ERLLC will access the work area using one or more manlifts and will erect the mini-containments and conduct abatement from the manlift(s). Aggressive final clearance sampling via PCM will be conducted by a CDHPE-certified AMS within the mini-containment upon completion of removal and final cleaning.
